NASA Technical Memorandum 102661

Failure of the ERBE Scanner Instrument Aboard NOAA 10 Spacecraft and Results of Failure Analysis

May 1990

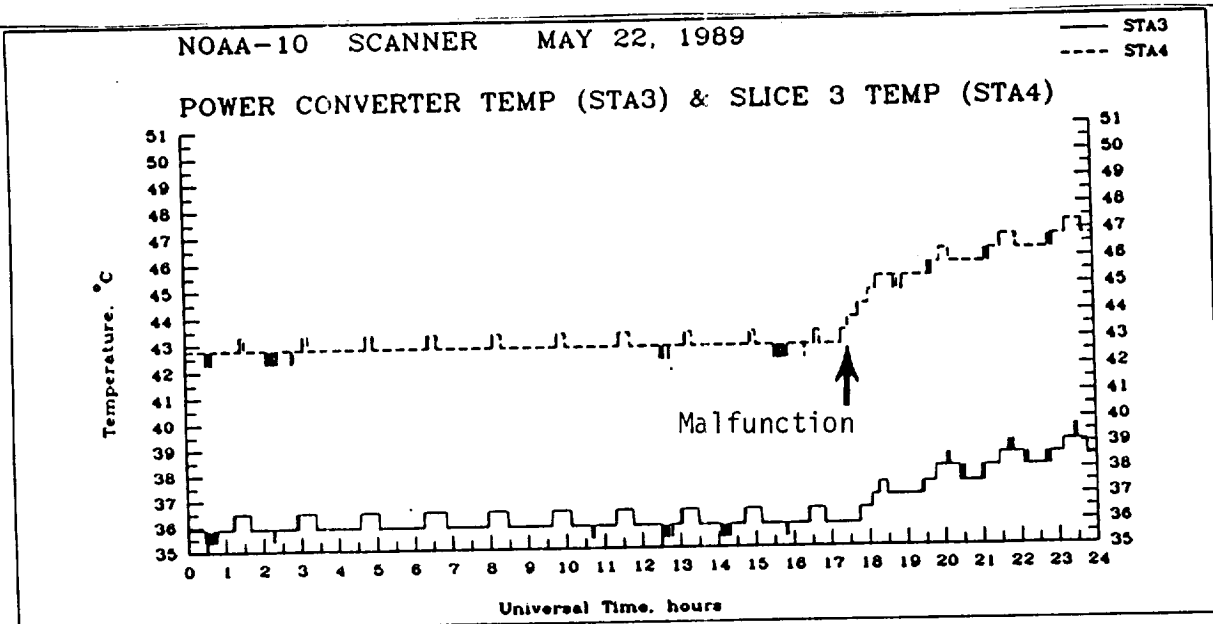
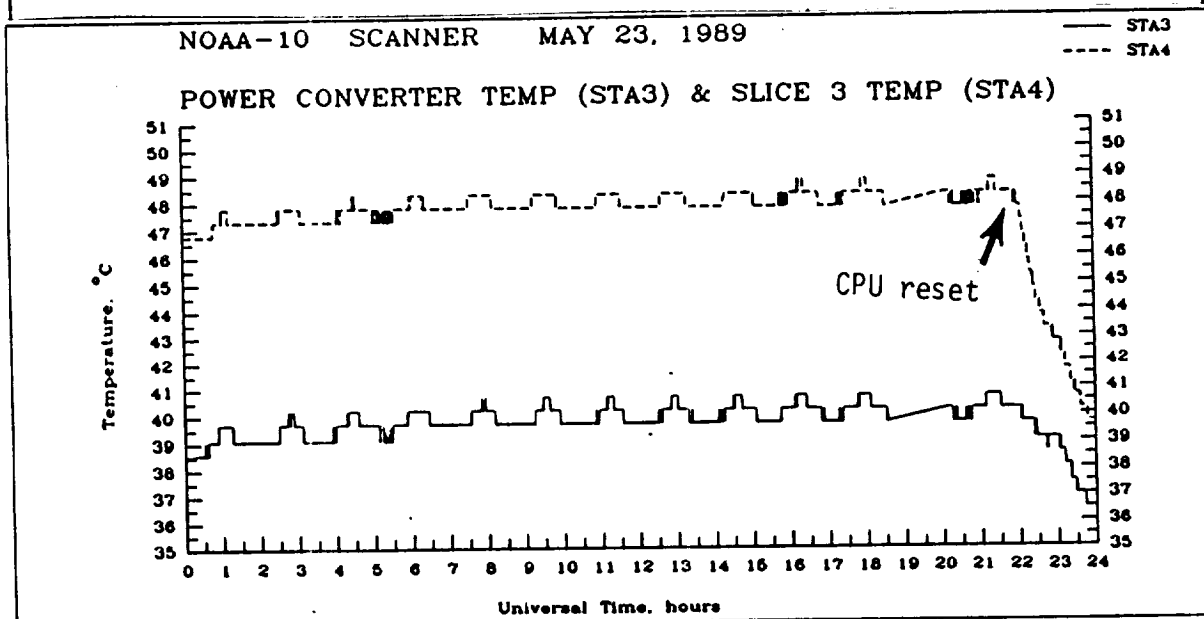
Instrument Temperatures Following Malfunction
Figure 1

At 17:03 Universal Time on May 22, all values in the primary output data (DIG A) of the scanner instrument on NOAA-10 went to zero. The bilevel data (DIG B) and several instrument temperatures and voltages (analog), which are output on a different data buses than that of the DIG A data, remained valid. The DIG B data indicated that the scanner elevation motor power remained on after the malfunction, and figure 1(a) shows how two of the instrument analog temperatures began to increase at the time of the malfunction.

sequence, the elevation motor power was apparently turned off automatically, and the DIG A data again reverted to zero values. Elevation position data, transmitted following a subsequent CPU Reset, indicates that the scanner elevation beam appeared to have achieved position lock at the normal Earth scan space-look position. Several times on May 23 and 24, the instrument was sent CPU Reset commands, followed by normal Earth scan mode commands. In every case, the instrument response was identical to the response received the first time these commands were sent on May 23. On May 26, a CPU Reset command, only, was sent to the instrument, and no other commands were sent until May 31. The DIG A data remained valid, and instrument housekeeping and radiometric data showed typical responses to the in-orbit heating environment during this five-day period.

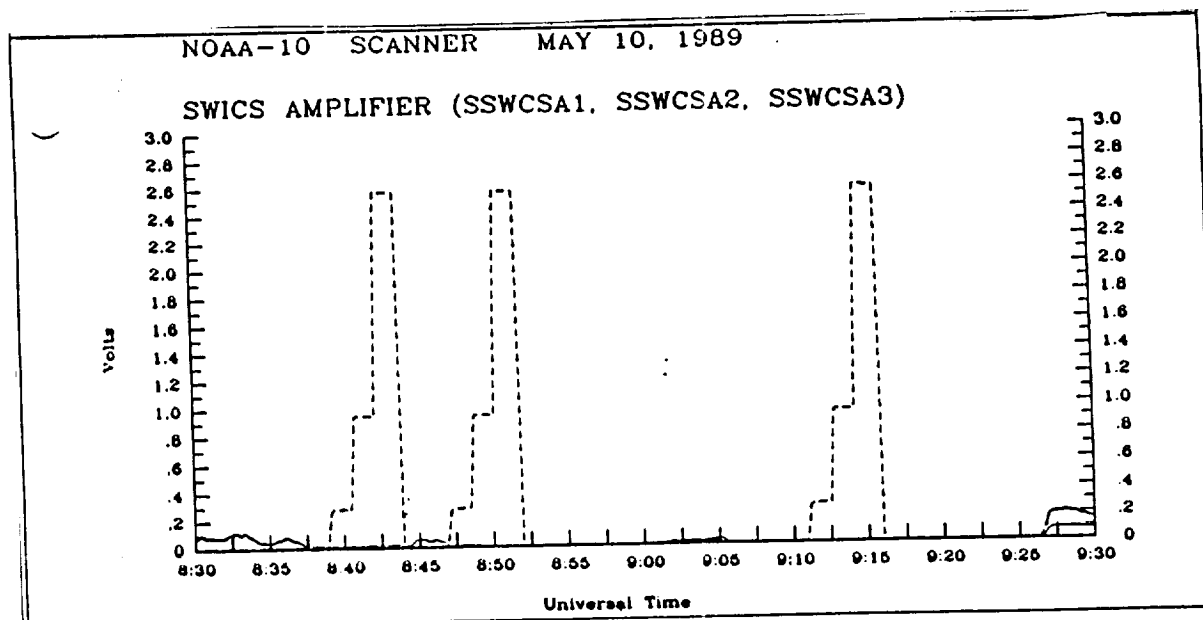
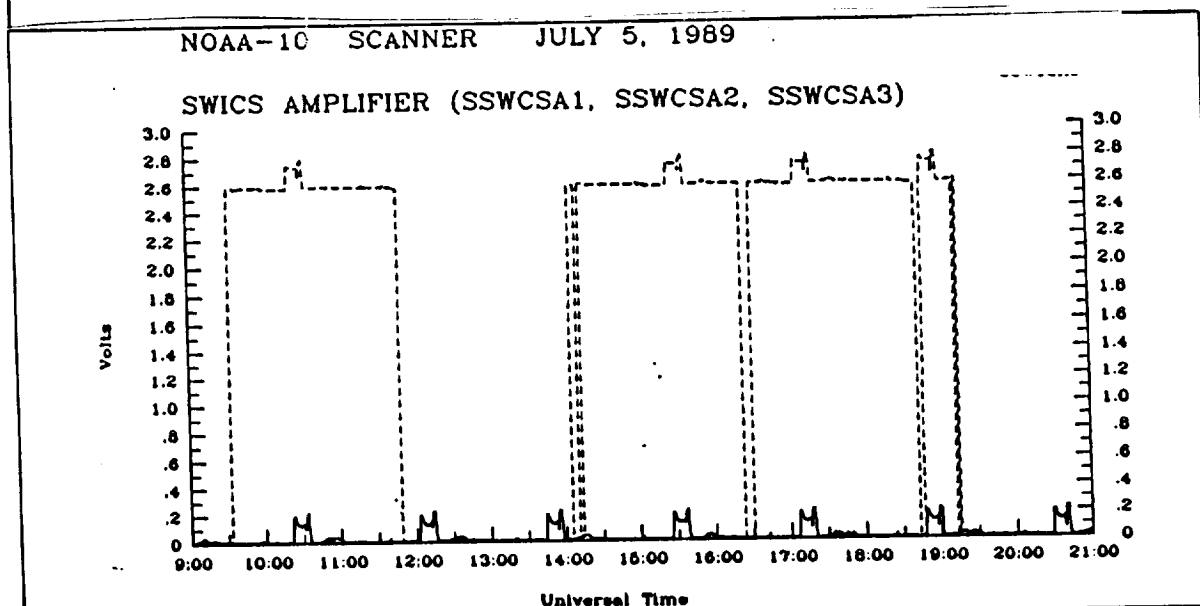
Internal Calibration Response
Before and After Malfunction
Figure 2

The internal calibration sequence command normally executes a series of SWICS modulated level commands from level 1 to level 3 at preset time intervals to create a profile as shown in figure 2a. However, when the internal calibration sequence was issued to the NOAA-10 scanner following the malfunction, a sequence of SWICS level 3 and SWICS off commands were executed with a

radically different time sequence as shown in figure 2b. The total number of SWICS commands was the same as for a normal sequence, and following the completion of the sequence the scanner returned to its "standby" mode. Primary instrument data (DIG A) remained valid throughout and following the internal calibration sequence.

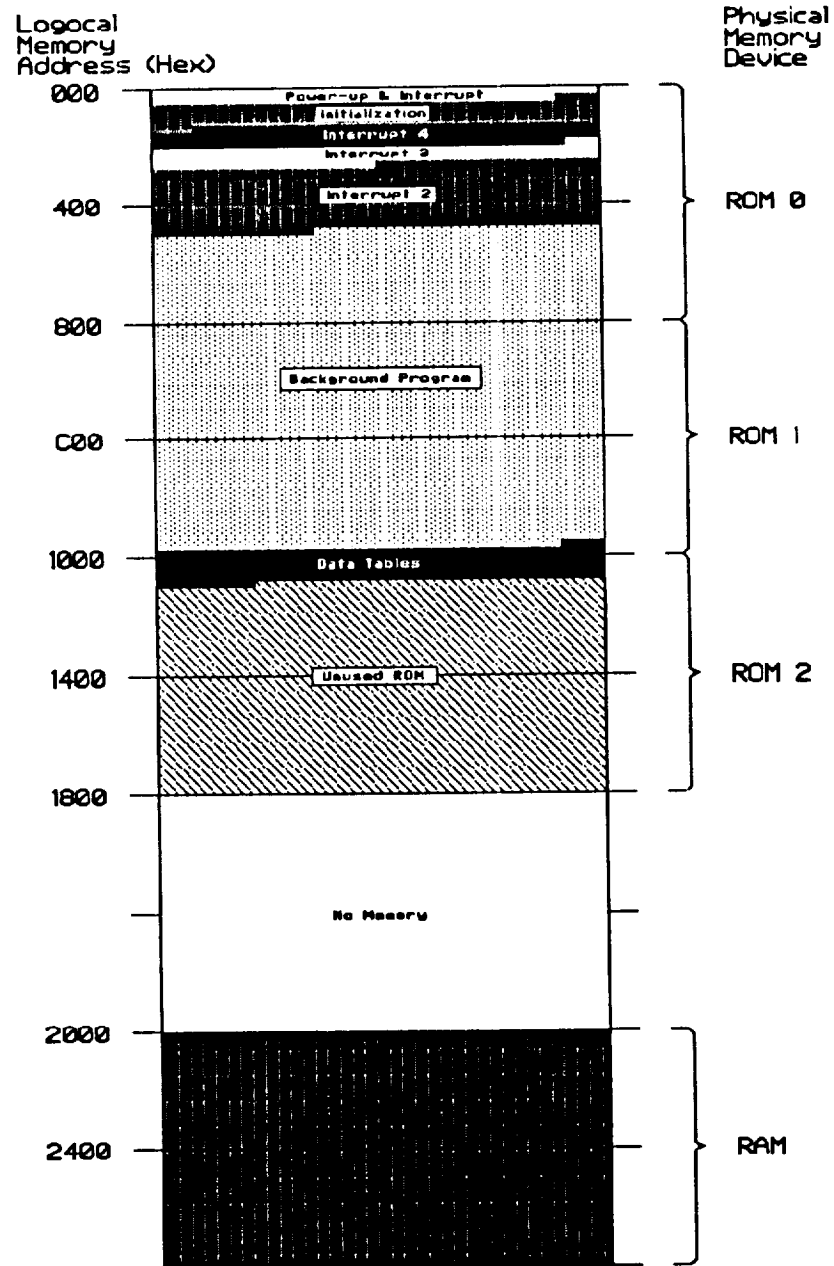
ERBE Scanner Memory Map
Figure 3

The CPU Reset command causes a hardware reset of the microprocessor; which in turn causes all internal registers to be cleared and a restart of the firmware code. The ROM code initialization causes the RAM memory to be cleared and initialization of selected scanner hardware including removal of power from the elevation motor drive circuit. The fact that the processor responded to a reset instruction and normal data transfers were restored, indicated that the spacecraft command and data transfer circuitry, spacecraft 1.2M Hz clock, counter and interrupt circuits are functioning normally, and that the microprocessor, ROM, and RAM memories are functioning normally for at least a substantial portion of the instruction set and memory area. Initialization, data acquisition, and telemetry transfers require proper operation of substantial portions of the background program as well as interrupts 3 and 4, and use large variable blocks in the RAM memory. See memory map figure 3.

The normal response of the scanner instrument to all azimuth commands indicated that the azimuth mechanism and drive are functioning normally, and supports the argument for proper computer operation. Execution of azimuth commands require the proper function of the interrupt service routine for interrupt 2 and a portion of the background program not required for initialization, data acquisition, or telemetry transfer. See memory map figure 3.
